## **Hawaii Red-Light Safety Camera Program Report & Engineering Study**

**Honolulu, Hawaii  
November 2022**

**SSFM**  
International

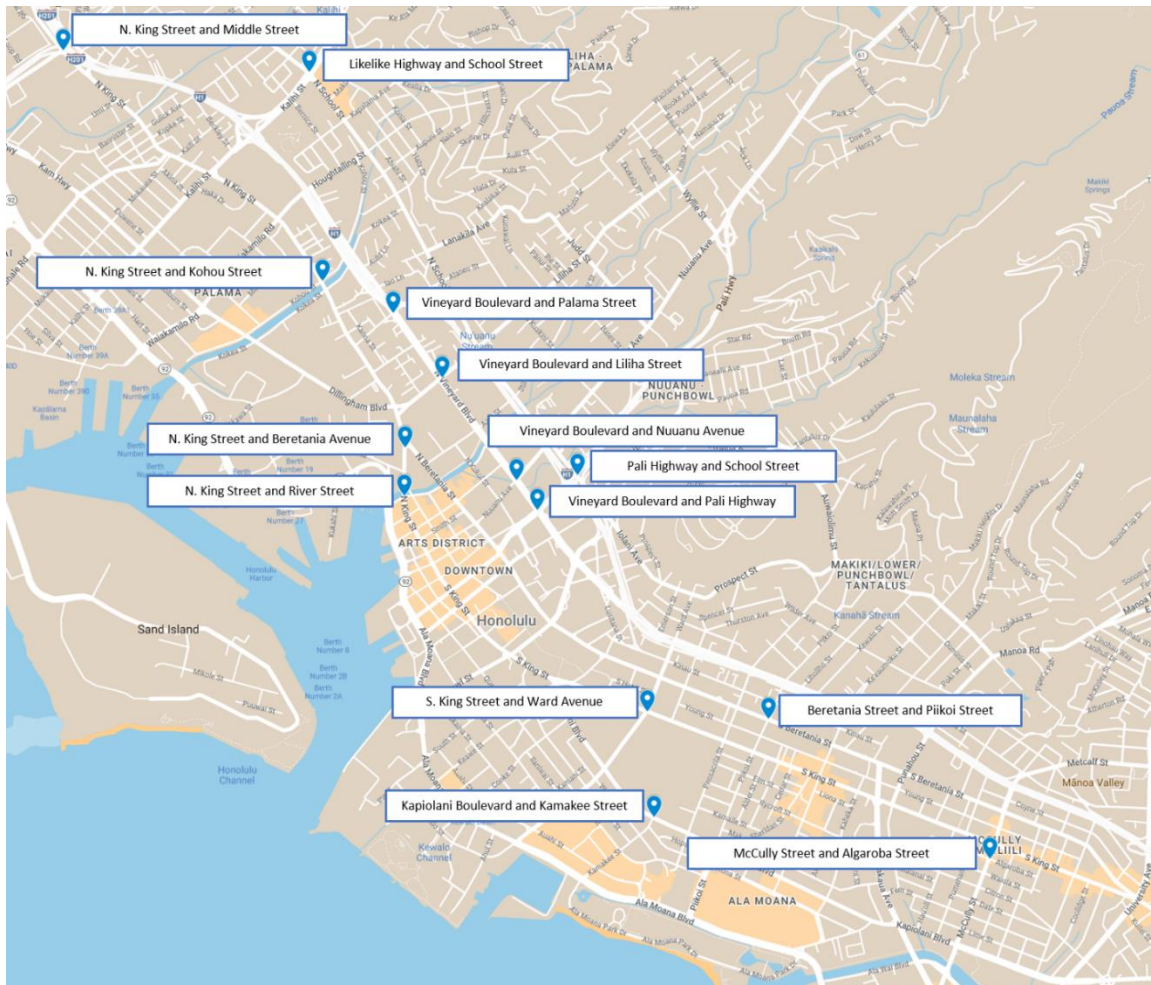
**Figure 2: Preselected Intersections for Red-Light Safety Camera Program**

The following 14 intersections (see Figure 2), in no particular order, were preselected by HDOT and DTS to be analyzed as part of this engineering study for the implementation of RLSCS:
